ONTARIO LINE GERRARD-CARLAW SOUTH TOC

388 Carlaw Avenue and 10 Dickens Street

TRANSIT-ORIENTED COMMUNITY HERITAGE EVALUATION

Appendix C: Condition Assessment

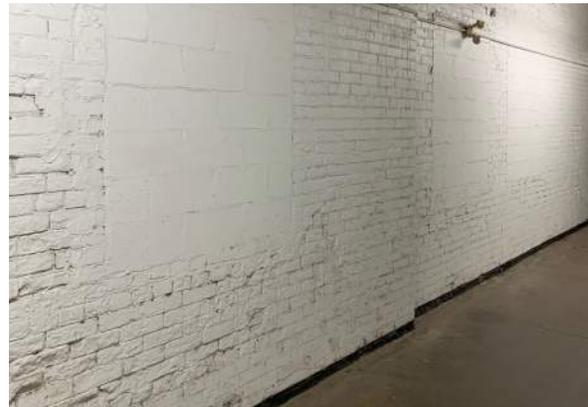
Figure 58. Brick with spalling and concrete block infill (ERA, 2022).

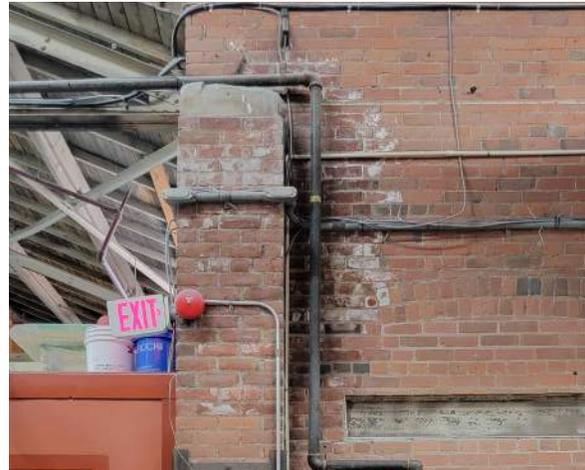
Figure 62. Interior brick pier with concrete cap in poor condition, with water and salt damage (ERA, 2022).

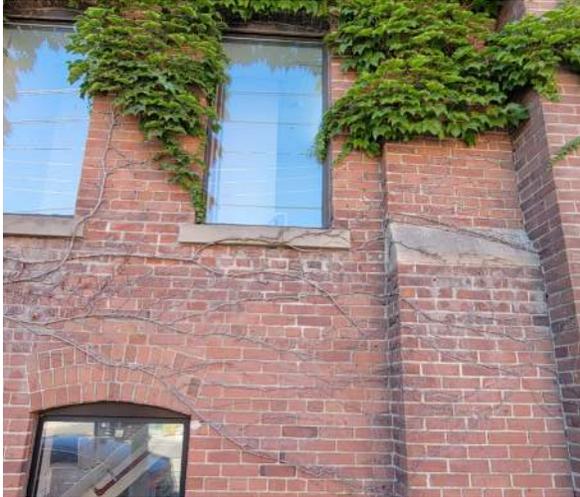
Figure 65. Cracked concrete sills and vine damage. Spalled brick and soiling on surface (ERA, 2022).

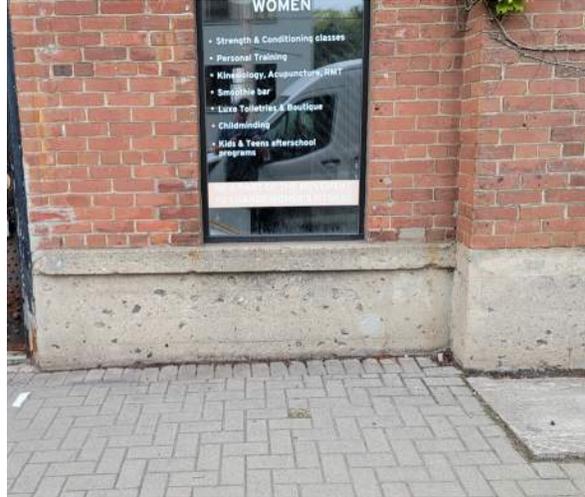
Figure 66. Deteriorated concrete surface and spalled brick at first three feet of masonry wall (ERA, 2022).

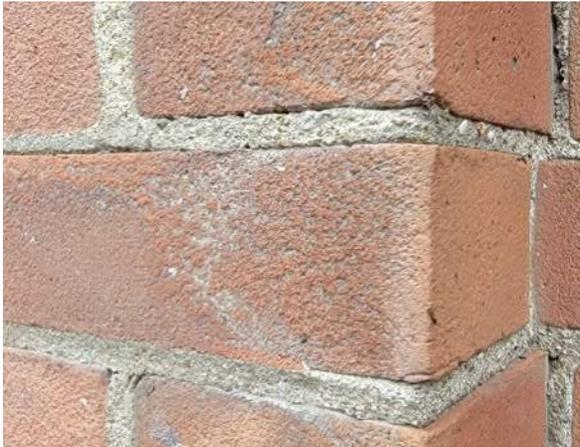
Figure 67. Exterior brick surface with evidence of abrasive cleaning (ERA, 2022).

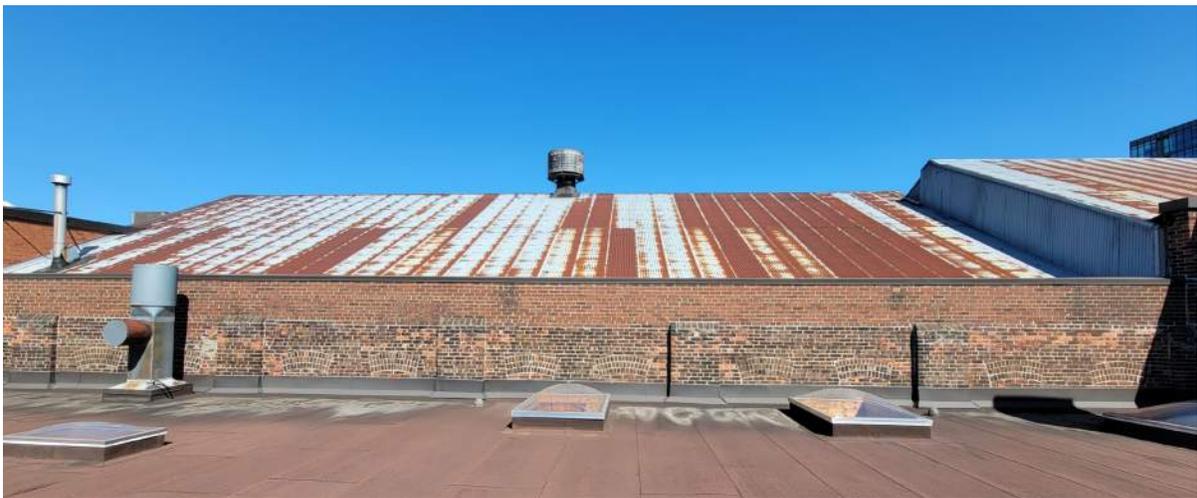
Figure 69. Corrugated metal roof with corrosion. Brick arches and piers rise above the roofline (ERA, 2022).

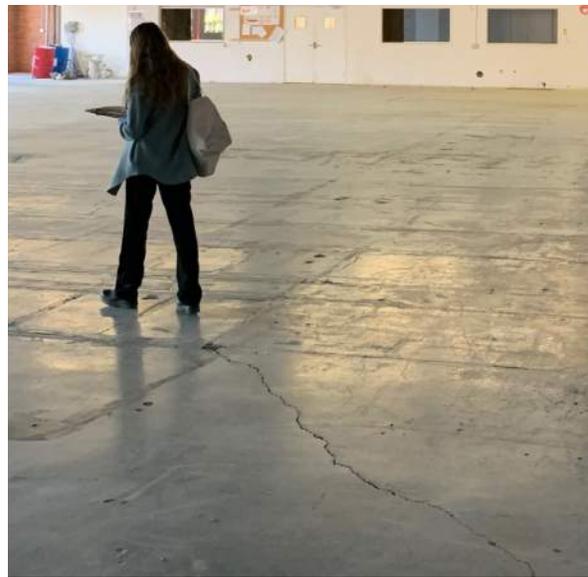
Figure 71. The second floor concrete floor with cracking (ERA, 2022).

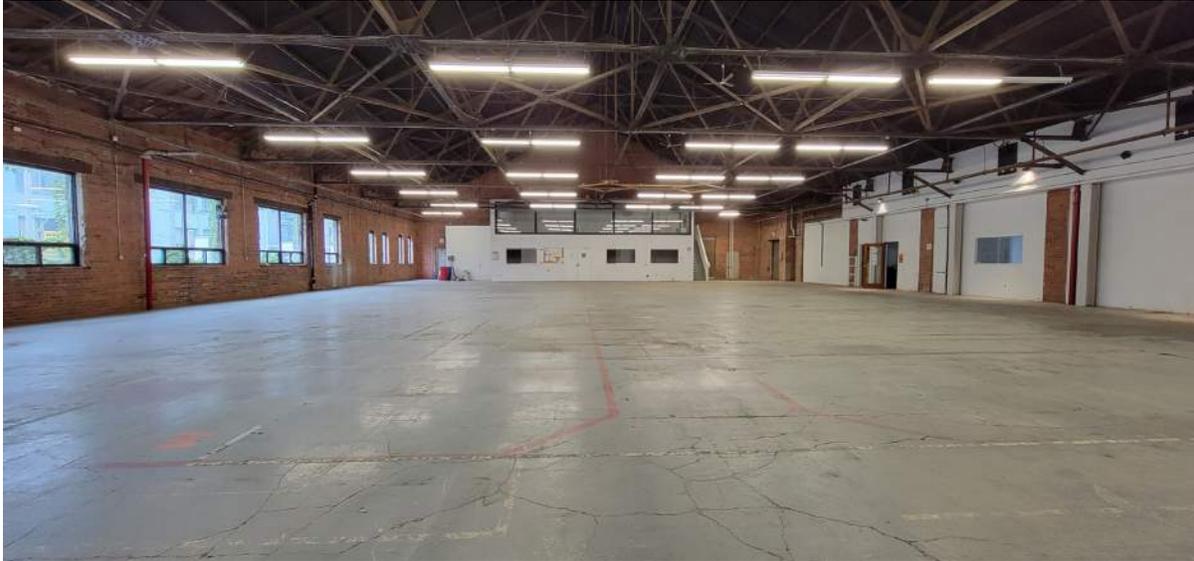
Figure 72. The second floor concrete floor with cracking and steel trusses spanning the east and west. The trusses are embedded in brick piers (ERA, 2022).

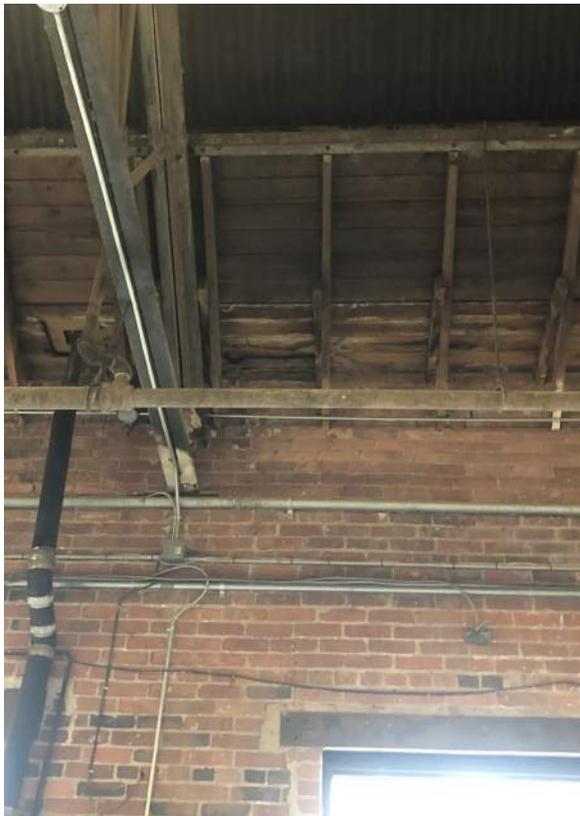
Figure 73. Steel and wood roof components with deterioration of wood decking at perimeter wall (ERA, 2022).

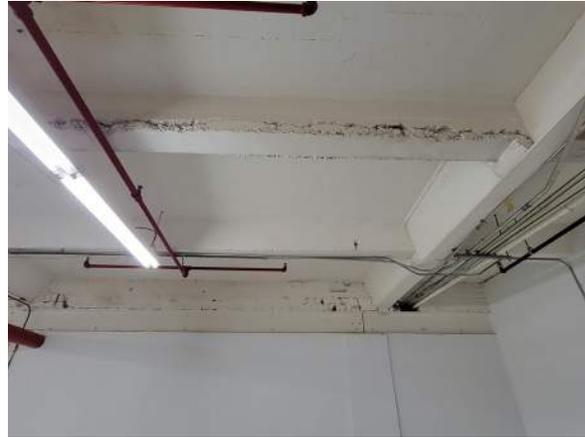
Figure 89. Concrete beam with missing material (ERA, 2022).

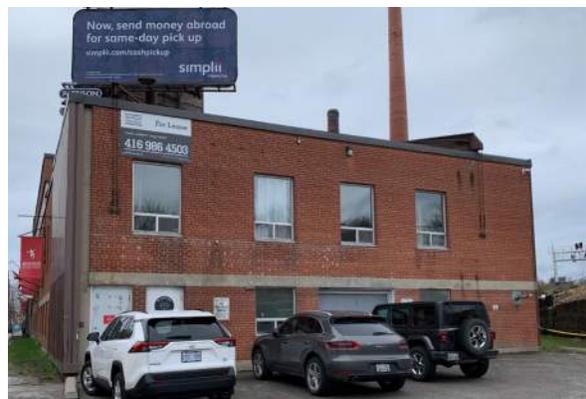
Figure 94. North elevation with soiling and steel corrosion (ERA, 2022).

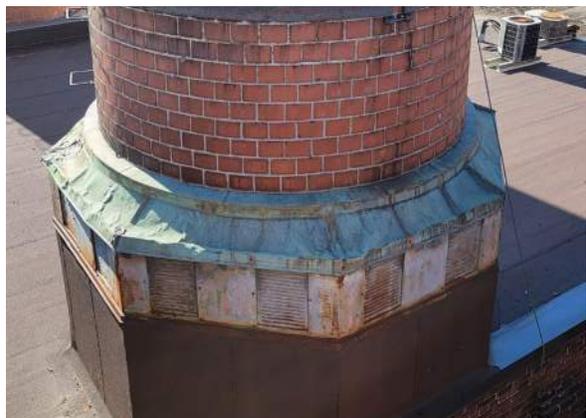
Figure 105. Damaged copper flashing of shorter east stack. Painted metal venting and steel bands with corrosion (ERA, 2022)

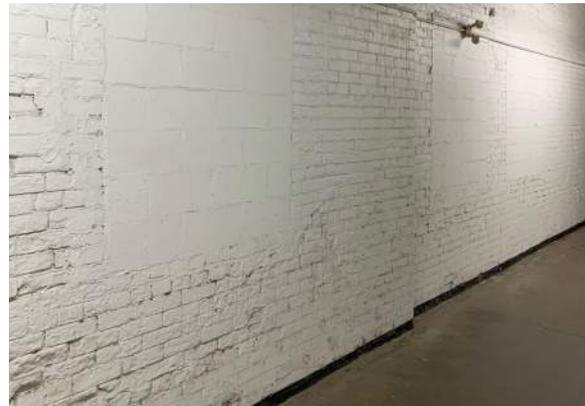
Figure 54. Brick with spalling and concrete block infill (ERA, 2022).

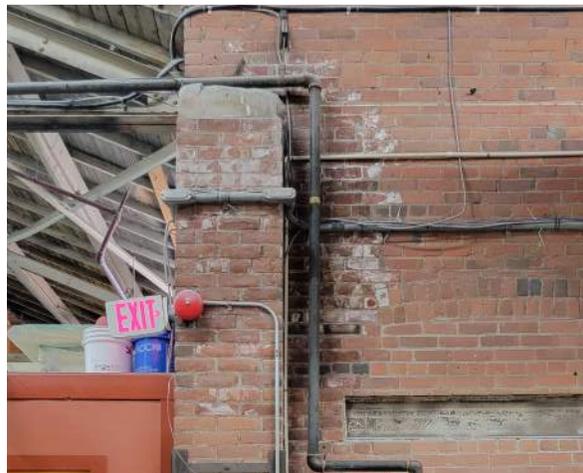
Figure 58. Interior brick pier with concrete cap in poor condition, with water and salt damage (ERA, 2022).

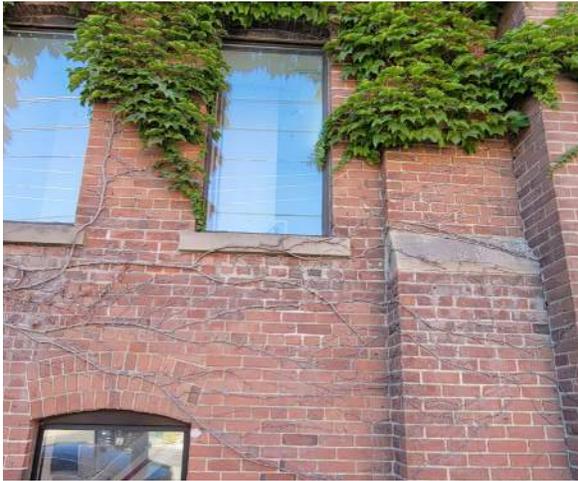
Figure 61. Cracked concrete sills and vine damage. Spalled brick and soiling on surface (ERA, 2022).

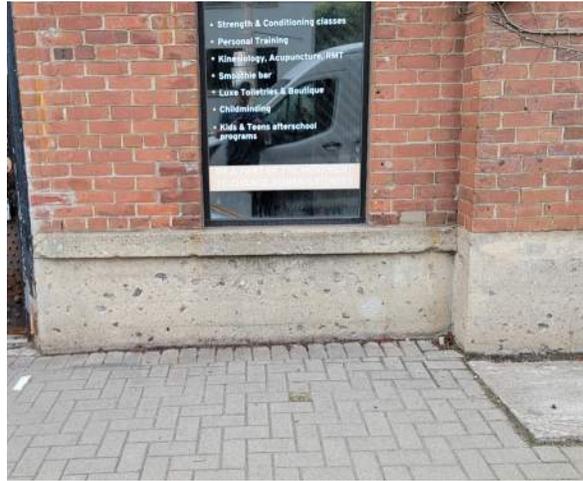
Figure 62. Deteriorated concrete surface and spalled brick at first three feet of masonry wall (ERA, 2022).

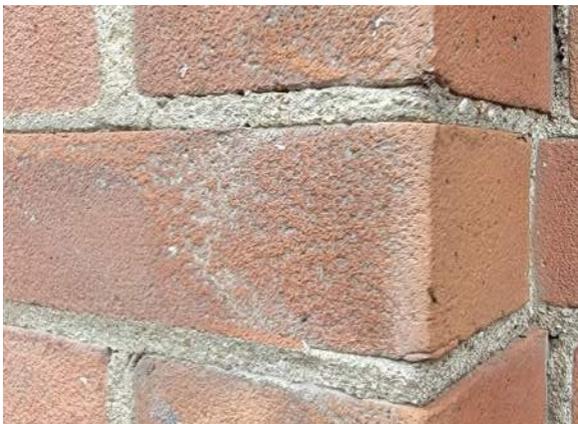
Figure 63. Exterior brick surface with evidence of abrasive cleaning (ERA, 2022).

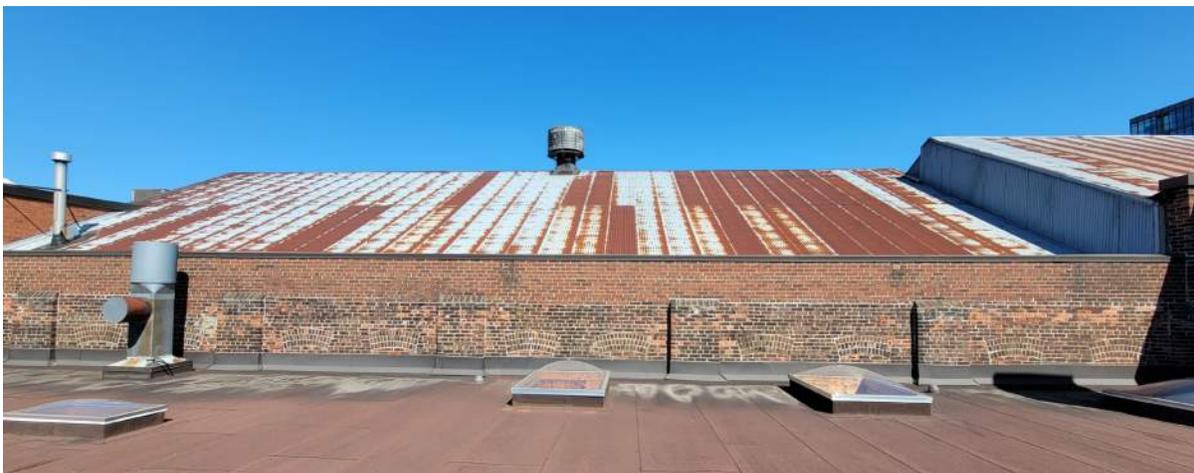
Figure 65. Corrugated metal roof with corrosion. Brick arches and piers rise above the roofline (ERA, 2022).

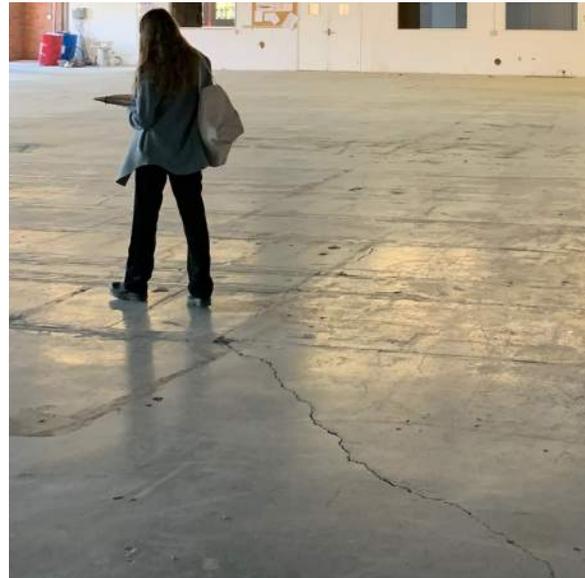
Figure 67. The second floor concrete floor with cracking (ERA, 2022).

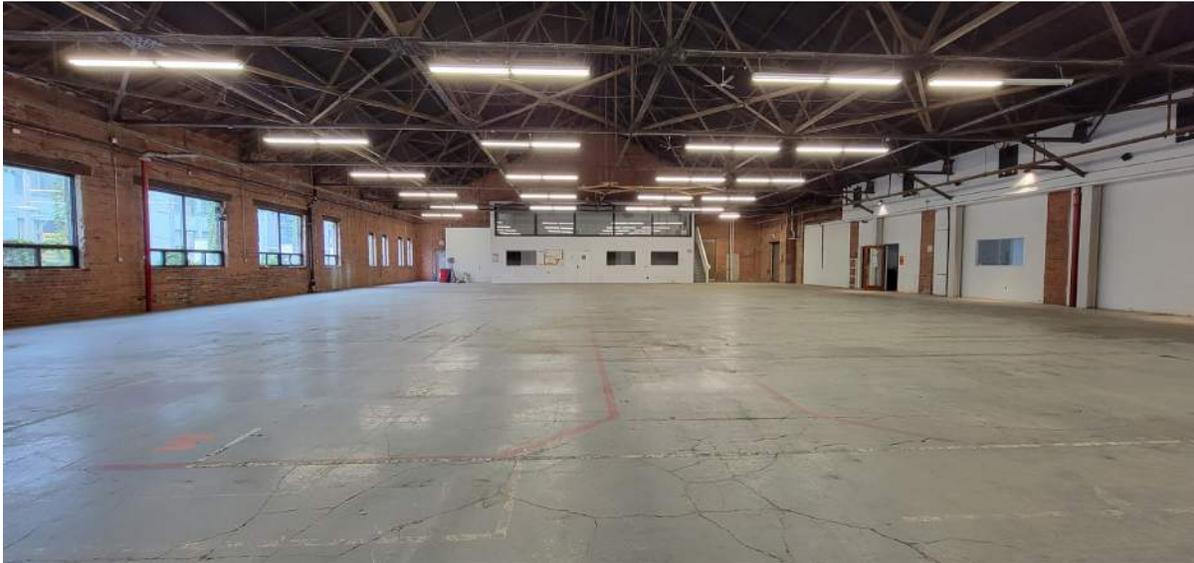
Figure 68. The second floor concrete floor with cracking and steel trusses spanning the east and west. The trusses are embedded in brick piers (ERA, 2022).

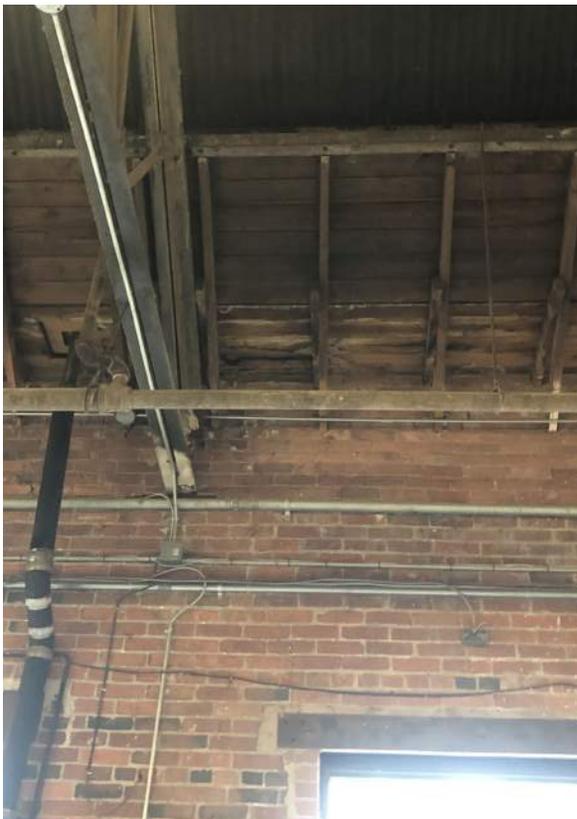
Figure 69. Steel and wood roof components with deterioration of wood decking at perimeter wall (ERA, 2022).

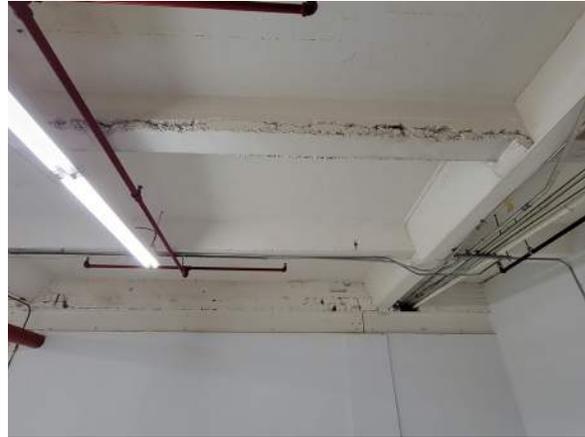
Figure 86. Concrete beam with missing material (ERA, 2022).

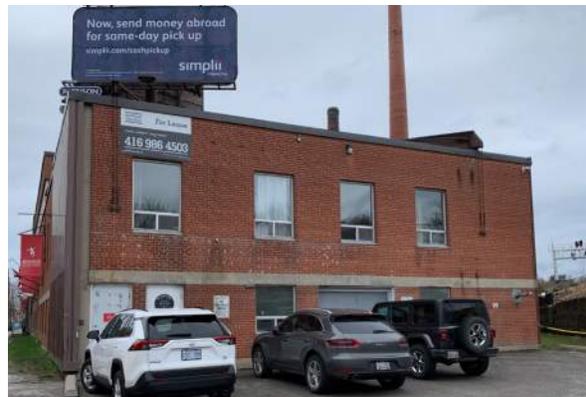
Figure 90. North elevation with soiling and steel corrosion (ERA, 2022).

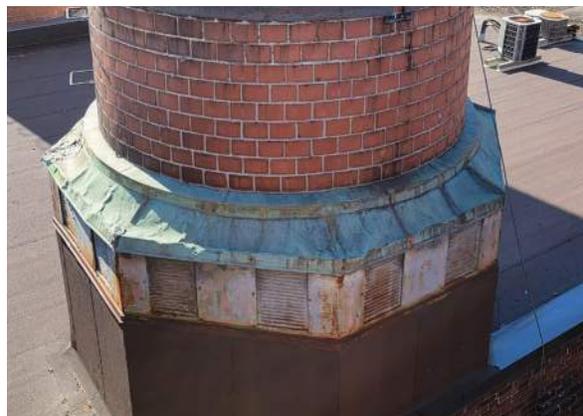
Figure 101. Damaged copper flashing of shorter east stack. Painted metal venting and steel bands with corrosion (ERA, 2022)
