ONTARIO LINE GERRARD-CARLAW SOUTH TOC

388 Carlaw Avenue and 10 Dickens Street

TRANSIT-ORIENTED COMMUNITY HERITAGE EVALUATION

Appendix C: Condition Assessment

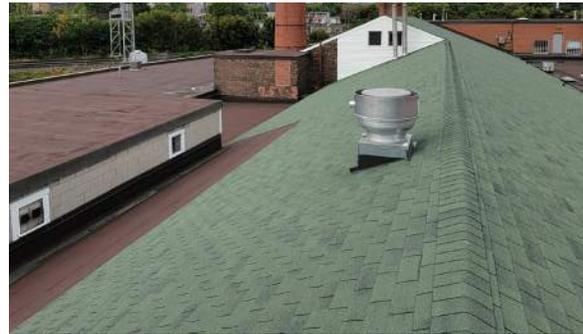
The oldest portion of the building was built in 1912 and sits near the centre of the Site. The 1912 portion of the building features a two-storey rectangular plan with the narrow end facing north and south. Its construction materials are visible above the roof-line and within units 204 through 207. Constructed mostly of brick, the building is set on a cast-in-place concrete foundation with brick piers that extend from grade to the top of the second floor where steel trusses are embedded into the brick piers on the interior to support the low-pitched gable roof. On the east and west sides, steel purlins support wood plank deck on two flat roof sections. The pitched roof is clad in green asphalt shingles and in fair condition. The exterior brick walls are in fair condition with spalling in some locations and general atmospheric staining. Painted metal flashing covers parapet walls and roof edges that appear to be failing in many locations. Exterior defects appear to be causing issues on the interior, with visible water damage and efflorescence found on interior masonry walls below. Exterior windows, sealants, and flashing are deteriorated and in poor condition.

Figure 54. View looking north along the green asphalt shingle roof of the 1912 construction (ERA, 2022).

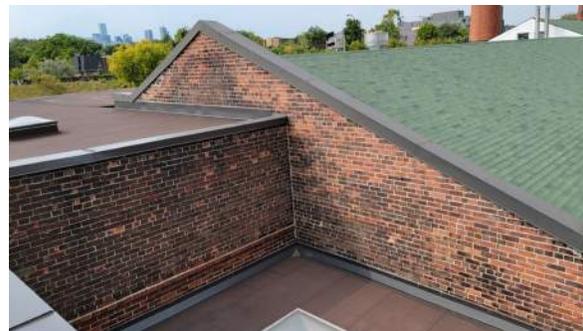
Figure 55. South gable wall in fair condition with metal flashed coping (ERA, 2022).

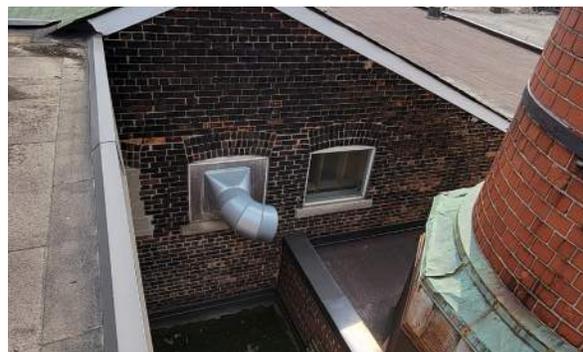
Figure 56. North gable brick wall with window infill and ductwork (ERA, 2022).

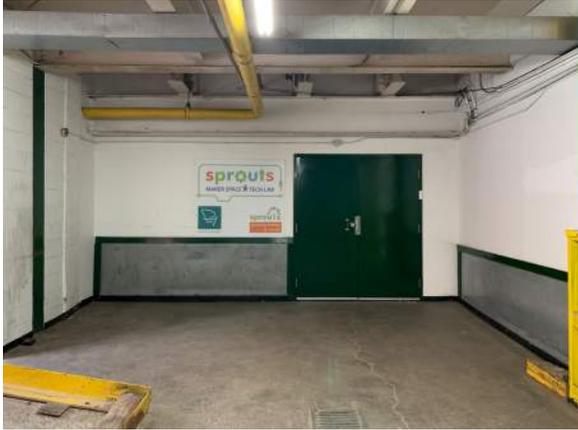
The first floor of the 1912 portion of the building consists of painted concrete block and brick partition walls that separate the large space into units facing east and west. The masonry in the hallways has been painted and is in poor condition, with brick spalling in some locations. Hallways include openings which have been infilled with concrete block. Brick walls throughout units are in fair condition with localized sections in poor condition. In some areas, exposed steel beams support the concrete floor above and tie into brick or concrete piers. In other areas, cast-in-place concrete beams in poor condition support the concrete floor above. Along the west side of the 1912 portion of the building, there is separation of the pier and slab from the vertical wall which may be due to structural movement. Loading areas appear to be in fair condition. Freight elevators are operational. The concrete floor is in fair condition, with some areas in poor condition.

Figure 59. Concrete floor in hallway (ERA, 2022).

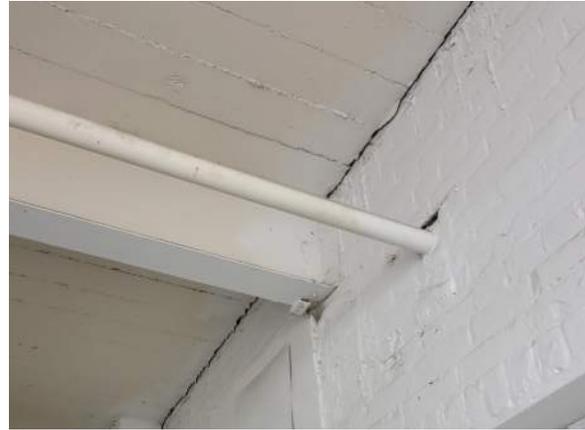
Figure 60. Separation of pier and slab from vertical wall at first floor along west side of 1912 portion of the building which may be due to structural movement (ERA, 2022).

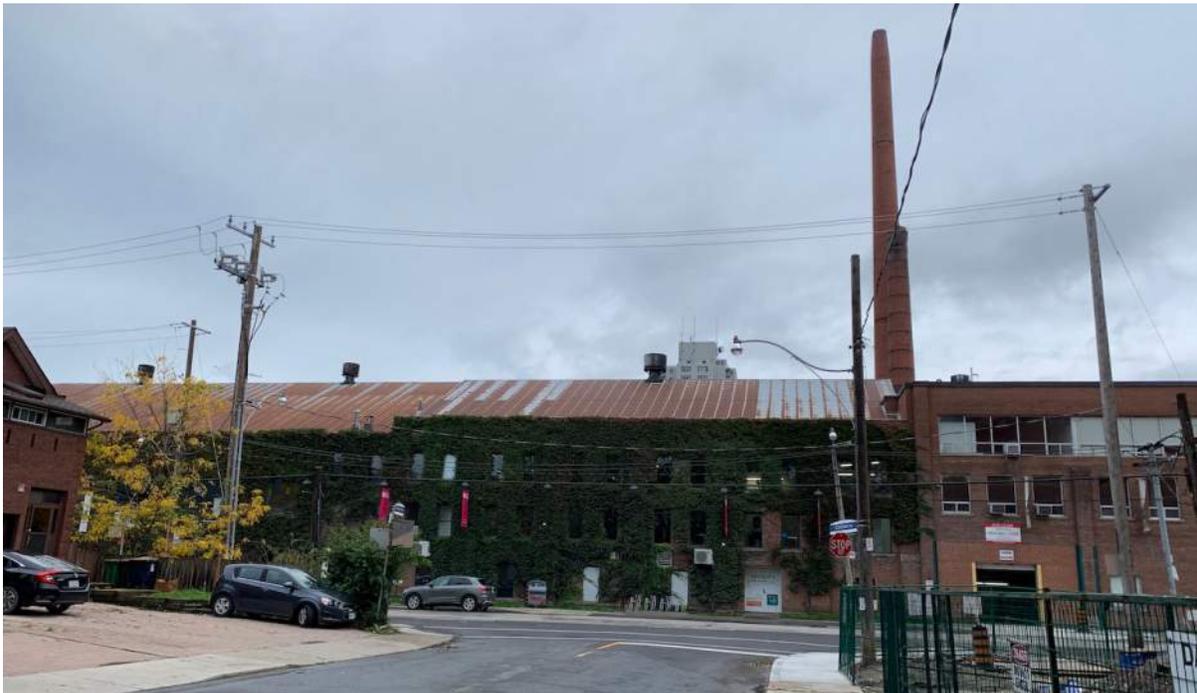
The 1913-1924 portion of the building fronting Carlaw Avenue is constructed mainly of brick, with a cast-in-place concrete foundation. The east elevation includes a triple wythe brick wall comprised of 14 bays, with brick piers marking bay divisions. Openings in the wall help determine that the triple wythe brick wall extends from ground to roof. The top of the wall is capped with clay coping tiles. Vines growing on the east elevation conceal some of the masonry and openings. Both the interior and exterior masonry show evidence of abrasive cleaning. The surface of the brick does not appear to be compromised. Overall the brickwork on the exterior is in fair condition, with some areas that include spalled brick and soiling. The original concrete foundation is in fair condition, with areas of deterioration where the surface has delaminated and exposed aggregate is noticeable. Concrete sills and pier caps are in poor condition with visible cracking and mortar loss. A corrugated metal roof is built over interior steel trusses and is divided into two sections, with the southern section having a greater span. The metal roof appears to be in poor condition with rust and evidence of previous repairs. A square chimney, concealed from the street and only visible from the top of the roof, is in fair condition. Parapets exposed above the roofline appear to be in fair condition. Aluminium windows with thermal glazing along Carlaw Avenue are in good condition.

Figure 64. East elevation of the 1913-1924 portion of the building (ERA, 2022).

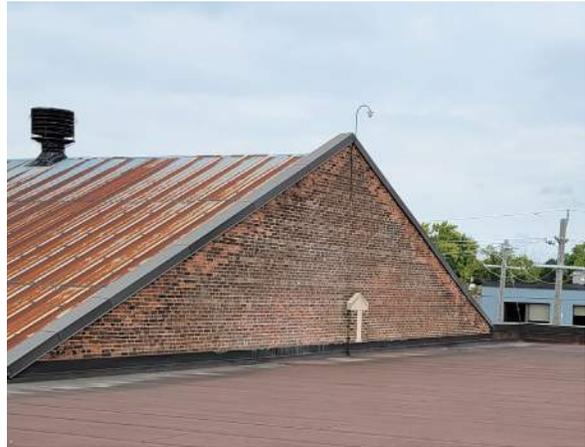
Figure 68. South gable partially exposed above the flat roof of a later extension south (ERA, 2022).

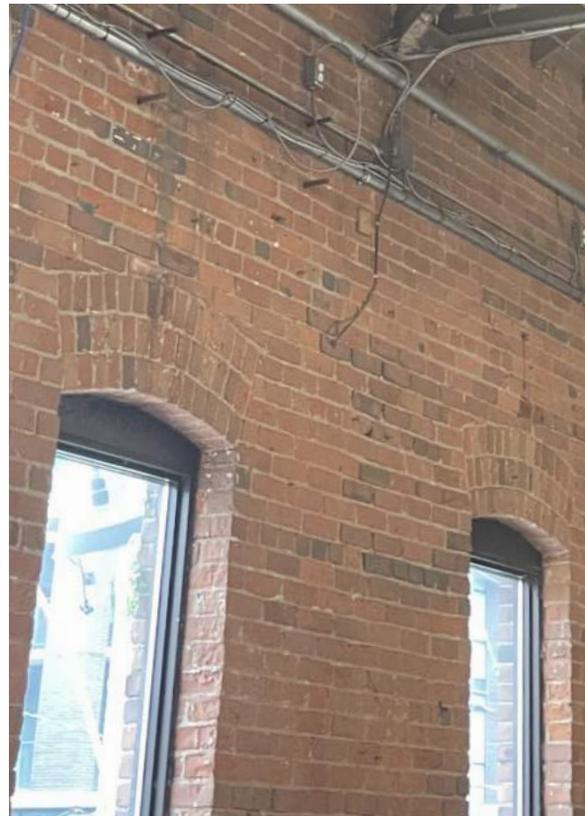
Figure 74. Window openings with segmental arch (ERA, 2022).

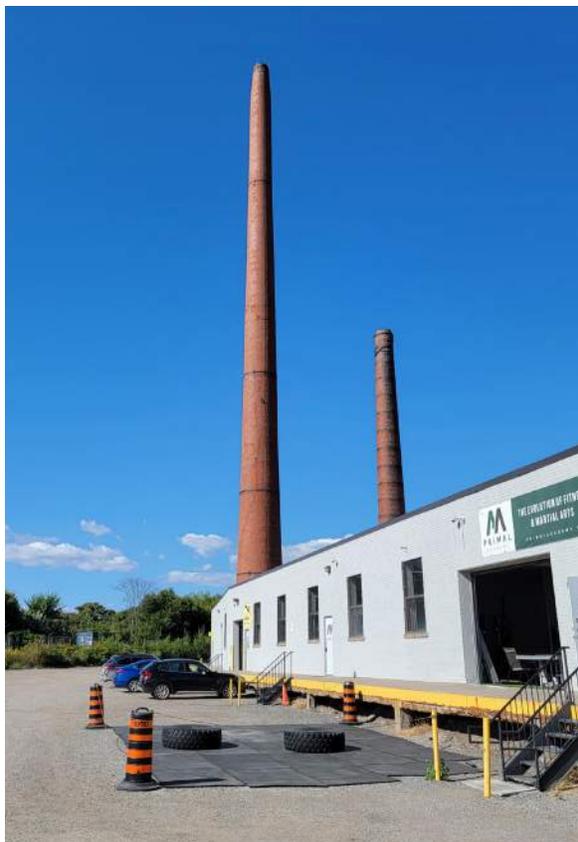
The 1939-1950 west addition has a painted brick exterior, aluminium windows, and loading docks that are in poor condition. The exterior of the brick wall has visible signs of spalling and mortar loss. The parapet coping includes clay tiles or painted metal flashing in good condition. The membrane roof is in poor condition with visible water pooling in sloped sections and noticeable surface wear. This portion of the building includes hallways, elevators, stairs and loading areas. Interiors include steel columns with supporting steel beams and wood planking.

Figure 75. West elevation loading dock at the rear of the building (ERA, 2022).

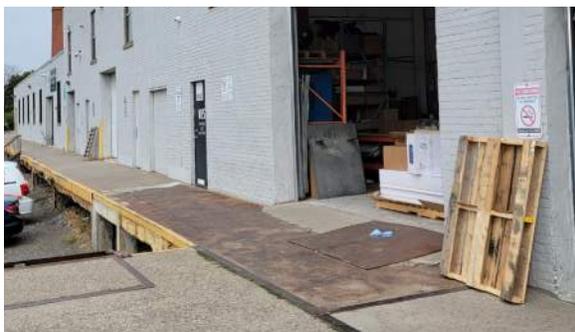
Figure 79. West elevation overhead door with corroded loading dock. Painted brick is deteriorated with extensive mortar loss on the upper portion of the wall (ERA, 2022).

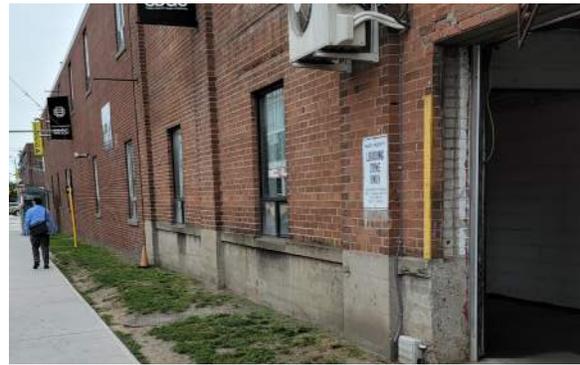
The east elevation of the 1939-1950 south addition features red brick walls, a concrete base, flat-headed window openings with precast concrete sills, and brick piers marking bay divisions. The masonry is in fair condition with localized soiling, mortar loss and deterioration. Openings at grade have been modified to create additional loading areas. All windows and doors have been changed to aluminium with double glazing. The concrete foundation and water-shedding concrete elements, including sills and pier caps, are in fair condition. Brick on the west elevation is painted and in fair condition, except at the south end where there is areas of brick spalling and mortar loss. Metal flashing and clay coping are generally in good condition. The loading dock has surface corrosion and appears to be deteriorated at grade. Concrete piers are crumbling and rust jacking was observed. The roofing membrane appears to be in poor condition, with ponding and a generally deteriorated surface.

Figure 77. Brick piers separate each bay. Openings at grade have been modified for additional loading areas (ERA, 2022).

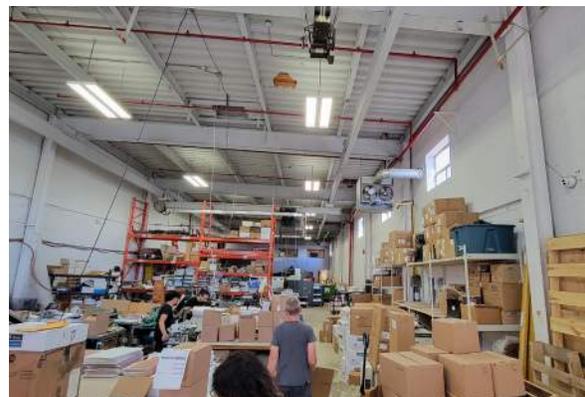
The interiors of the 1939-1950 south addition are varied in design with large open units. Exterior and demising walls are made of painted brick and concrete block which are in poor condition, with portions of the south wall in defective condition. Steel support columns are either embedded in the walls or along wall faces, providing clear span spaces. The steel system is in fair condition. The interior unit facing Carlaw Avenue is finished with wood floors and drywall and in good condition. A gantry crane midway through the space is no longer operational. The roof consists of steel purlins, rafters and a corrugated metal deck that are in fair condition.

Figure 84. Interior with painted masonry walls (ERA, 2022).

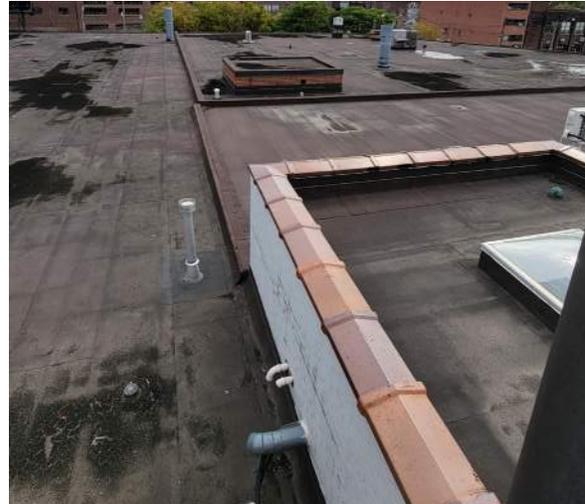
The brick facade on the east elevation is in fair condition. The masonry on the south elevation is in poor condition. The steel lintels of the flat headed window openings are in poor condition. Windows and doors are deteriorated and generally in poor condition. The flat roof areas are in poor condition with water pooling in many areas and worn membrane throughout. Clay coping is in good condition and much of the brick above the roof-line has been painted. Skylights appear to be in fair condition.

Figure 85. Flat roof sections with roofing membrane (ERA, 2022).

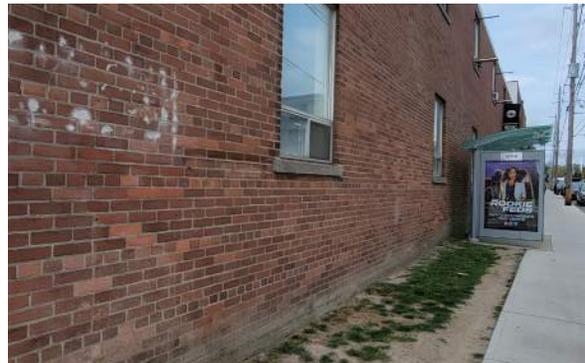
Figure 86. Brick on east elevation (ERA, 2022).

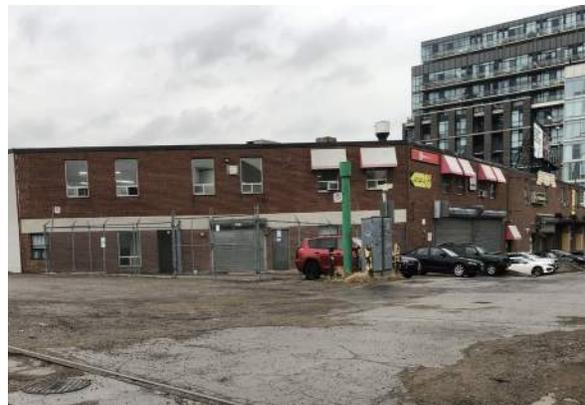
Figure 88. Windows and doors on south elevation (ERA, 2022).

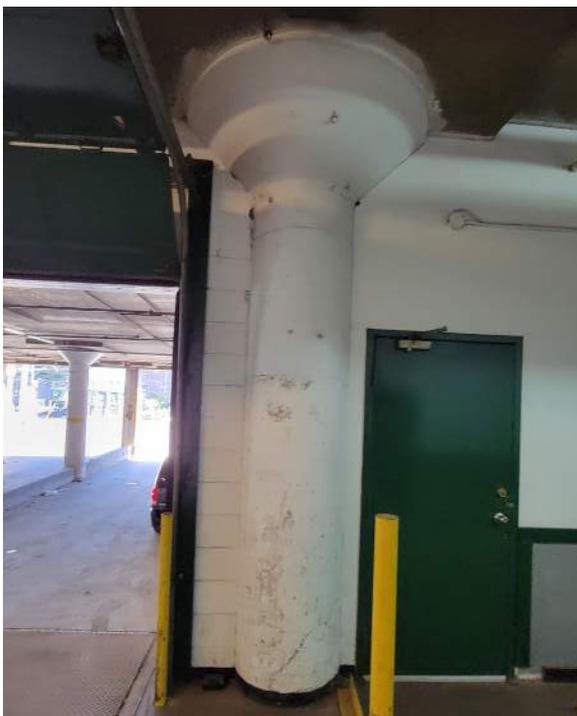
The 1950-1964 south addition features cast-in-place concrete columns with capitals and reinforced concrete slabs at the loading dock and service corridor, and with steel columns and beams in other areas. There is a slab on grade with no basement except for a below-grade boiler room. The concrete columns and capitals are in good condition with no signs of cracking. There is evidence of concrete beams in poor condition with missing material. The interior masonry walls are overall in fair condition with noticeable brick spalling, concrete block cracking and steel corrosion in some locations. The partially enclosed loading space is in poor condition. Many of the brick walls in the hallways are in poor condition. The service corridor with electrical equipment is in poor condition with noticeable brick deterioration throughout.

Figure 91. View of concrete column (ERA, 2022).

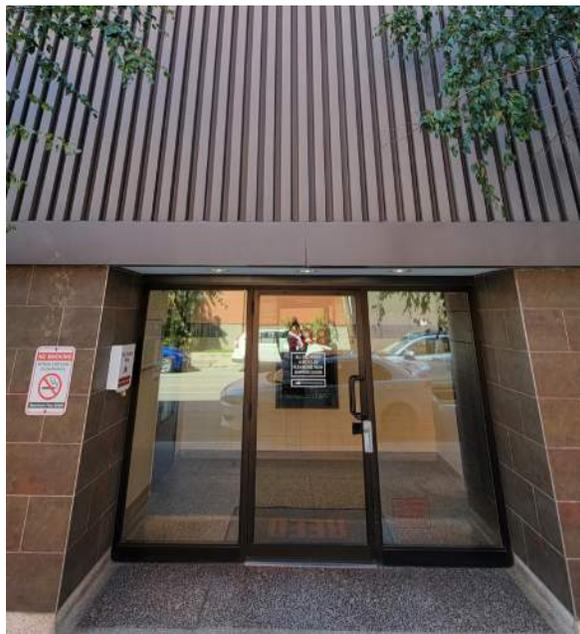
The 1939-1964 north addition was constructed in several phases, with a third floor added in 1960-1964. The main entrance to the north addition on the east elevation has been clad with painted corrugated metal in good condition, has tiled walls and multi-coloured terrazzo floors in fair condition. The entrance includes a typical commercial metal and glass door with two sidelights in fair condition. On the west elevation, openings have been modified and masonry is soiled. The condition of the west and north elevations of the building range from poor to fair. The roofing membrane is in poor condition.

Figure 95. Main entrance with terrazzo floors and tile on exterior walls, and painted metal cladding above (ERA, 2022).

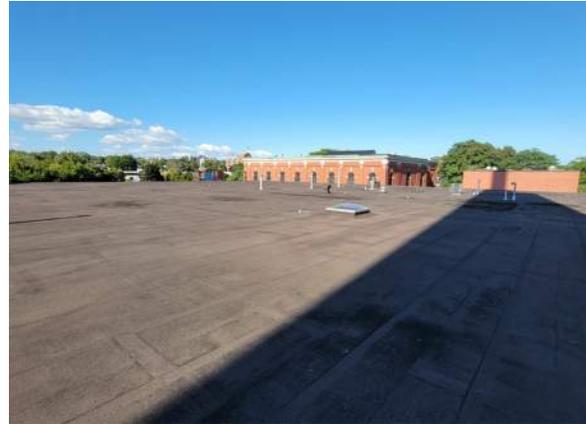
Figure 93. Roofing membrane (ERA, 2022).

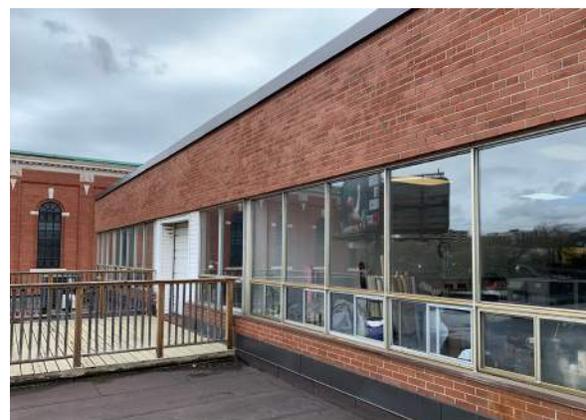
Figure 96. View looking east on the roof of the north addition (ERA, 2022).

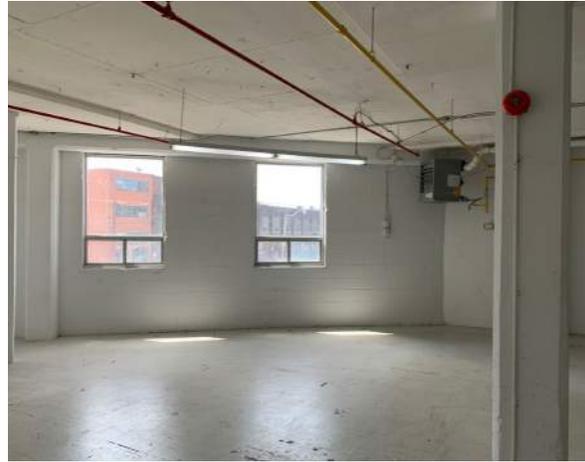
The interior of the north addition consist of concrete and steel structural members with concrete floors, brick and concrete block walls, and punched window openings. The masonry units are generally in good condition, with deterioration noted in loading areas and hallways in fair condition. The ground floor entrance on the east elevation includes tiled walls and a terrazzo floor in fair condition. The second floor includes concrete and steel columns and steel joists. The interiors appear to be in good condition. Aluminium windows are in poor condition with damaged frames, glazing and deteriorated sealants throughout.

Figure 97. Aluminium windows (ERA, 2022).

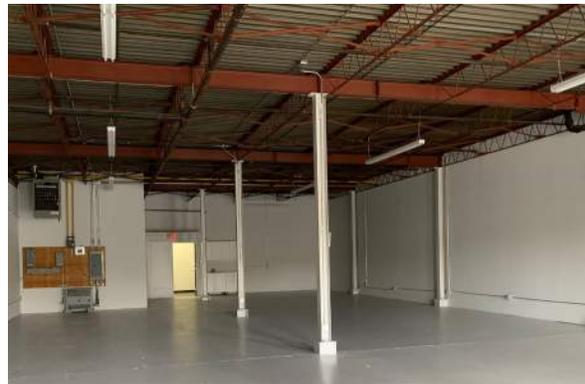
Figure 99. Steel columns connect to steel beams (ERA, 2022).

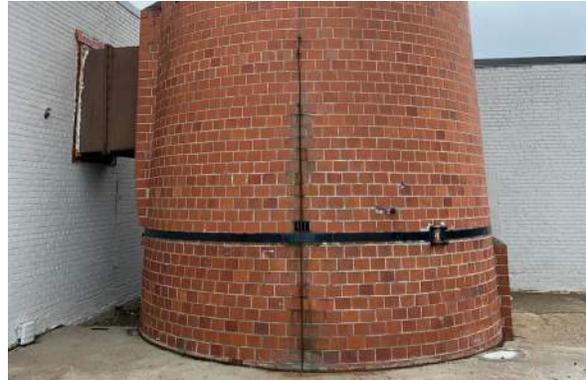
The west elevation of the north addition includes two chimney stacks that were observed from the roof and at grade. The taller c. 1969 west stack rests on an exterior concrete slab with a flue duct connecting it to the building and a cast steel ash door on the west side. The stack appears to have had previous repairs, with many bricks replaced. Some of the brick exhibits soiling and spalling. Vertical cracking was not visible. Tension bands and the grounding system are in fair condition, with some evidence of corroded steel. The west stack is generally in fair condition. The shorter c. 1940 east stack has numerous tension steel straps with surface corrosion, and overall appears to be in poor condition with masonry spalling, vertical cracking and soiling. The shorter east chimney emerges from a two storey area of the building with an octagonal base with venting, and copper flashing. The metal is in poor condition with open seams and visible corrosion.

Figure 102. Taller west chimney exhibiting soiling, spalling and rusted steel tension bands (ERA, 2022).

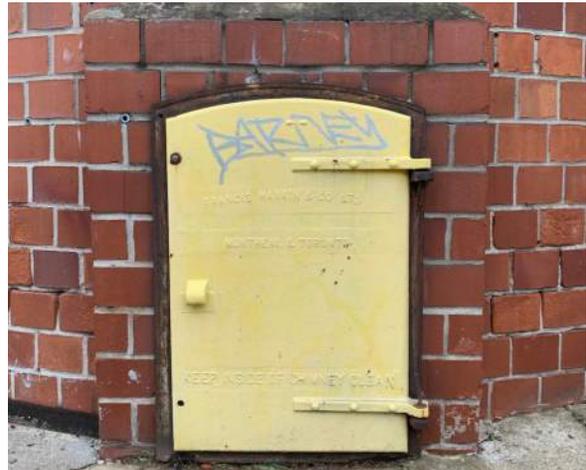
Figure 103. Ash door at the taller west chimney (ERA, 2022).

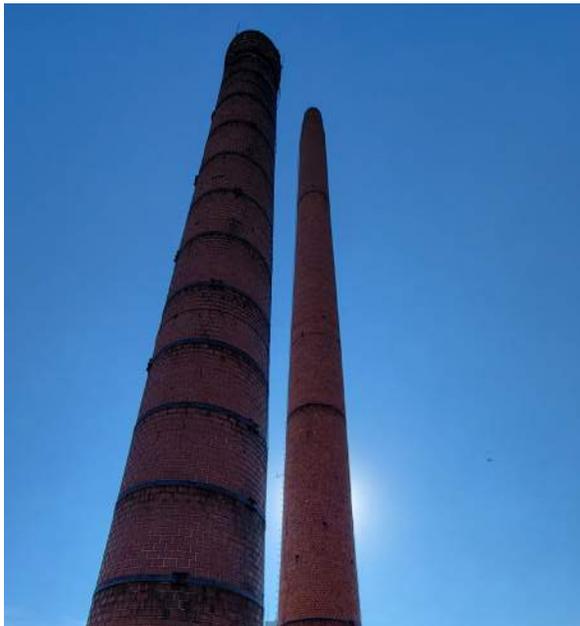
Figure 104. The shorter east chimney in the foreground with steel strapping, and taller west chimney beyond (ERA, 2022).

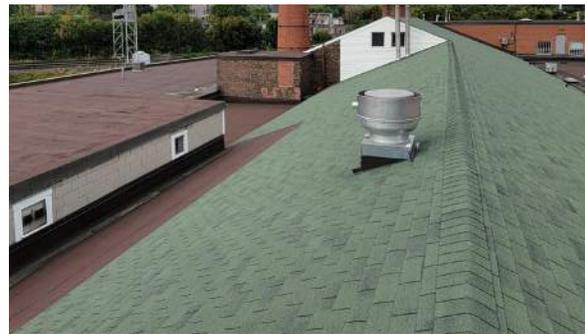
Figure 50. View looking north along the green asphalt shingle roof of the 1912 construction (ERA, 2022).

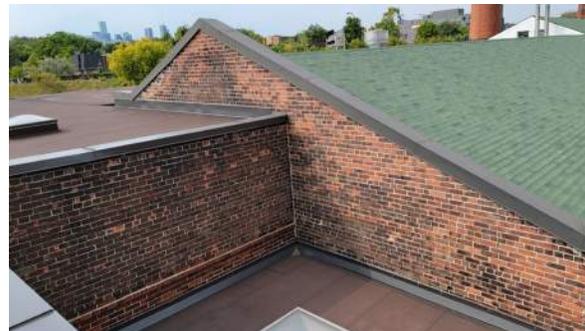
Figure 51. South gable wall in fair condition with metal flashed coping (ERA, 2022).

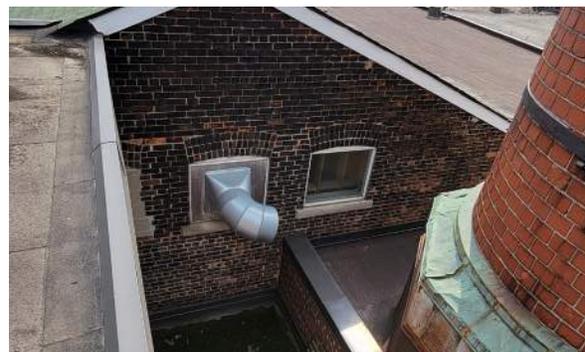
Figure 52. North gable brick wall with window infill and ductwork (ERA, 2022).

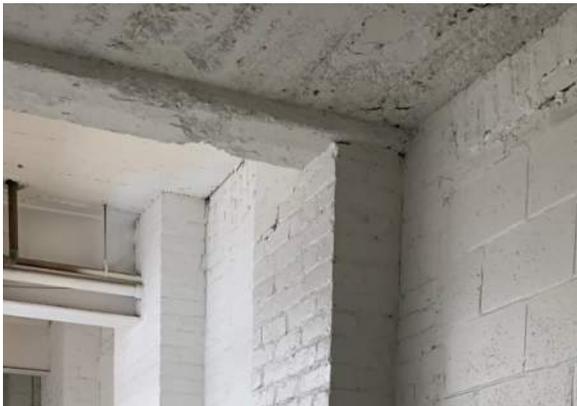
Figure 53. Concrete beam supports the concrete floor above in first floor hallway (ERA, 2022).

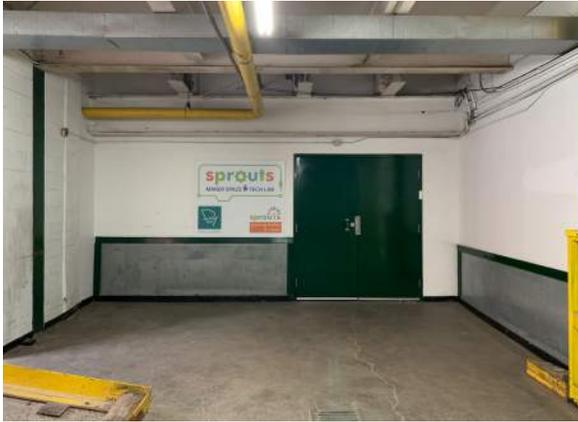
The first floor of the 1912 portion of the building consists of painted concrete block and brick partition walls that separate the large space into units facing east and west. The masonry in the hallways has been painted and is in poor condition, with brick spalling in some locations. Hallways include openings which have been infilled with concrete block. Brick walls throughout units are in fair condition with localized sections in poor condition. In some areas, exposed steel beams support the concrete floor above and tie into brick or concrete piers. In other areas, cast-in-place concrete beams in poor condition support the concrete floor above. Along the west side of the 1912 portion of the building, there is separation of the pier and slab from the vertical wall which may be due to structural movement. Loading areas appear to be in fair condition. Freight elevators are operational. The concrete floor is in fair condition, with some areas in poor condition.

Figure 55. Concrete floor in hallway (ERA, 2022).

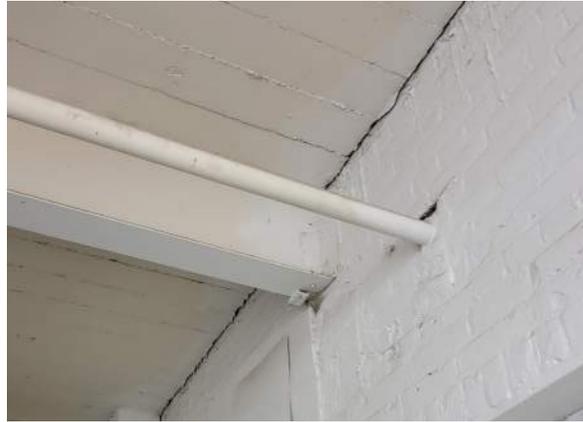
Figure 56. Separation of pier and slab from vertical wall at first floor along west side of 1912 portion of the building which may be due to structural movement (ERA, 2022).

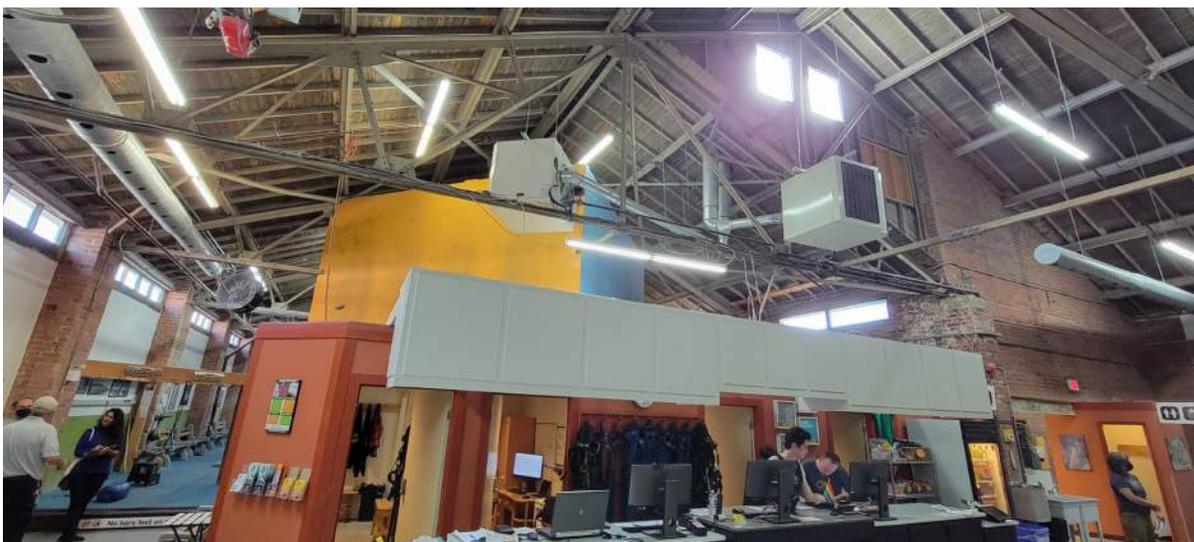
Figure 59. View of Unit 204 looking south, including steel trusses spanning east-west (ERA, 2022).

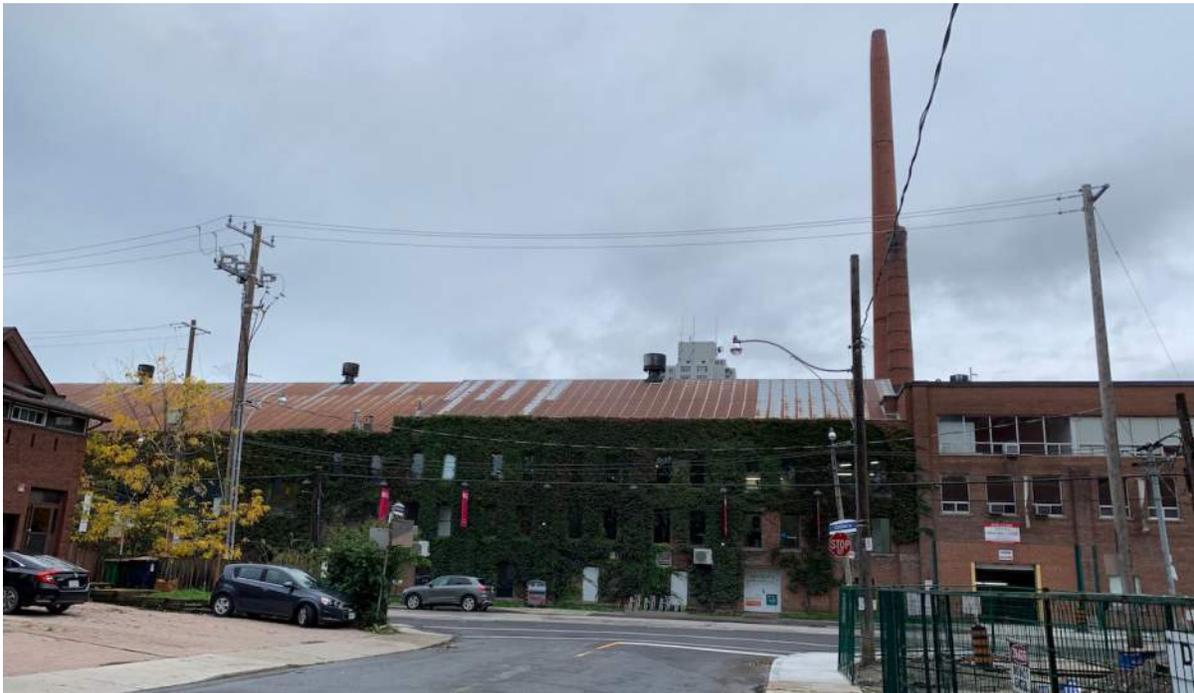
The 1913-1924 portion of the building fronting Carlaw Avenue is constructed mainly of brick, with a cast-in-place concrete foundation. The east elevation includes a triple wythe brick wall comprised of 14 bays, with brick piers marking bay divisions. Openings in the wall help determine that the triple wythe brick wall extends from ground to roof. The top of the wall is capped with clay coping tiles. Vines growing on the east elevation conceal some of the masonry and openings. Both the interior and exterior masonry show evidence of abrasive cleaning. The surface of the brick does not appear to be compromised. Overall the brickwork on the exterior is in fair condition, with some areas that include spalled brick and soiling. The original concrete foundation is in fair condition, with areas of deterioration where the surface has delaminated and exposed aggregate is noticeable. Concrete sills and pier caps are in poor condition with visible cracking and mortar loss. A corrugated metal roof is built over interior steel trusses and is divided into two sections, with the southern section having a greater span. The metal roof appears to be in poor condition with rust and evidence of previous repairs. A square chimney, concealed from the street and only visible from the top of the roof, is in fair condition. Parapets exposed above the roofline appear to be in fair condition. Aluminium windows with thermal glazing along Carlaw Avenue are in good condition.

Figure 60. East elevation of the 1913-1924 portion of the building (ERA, 2022).

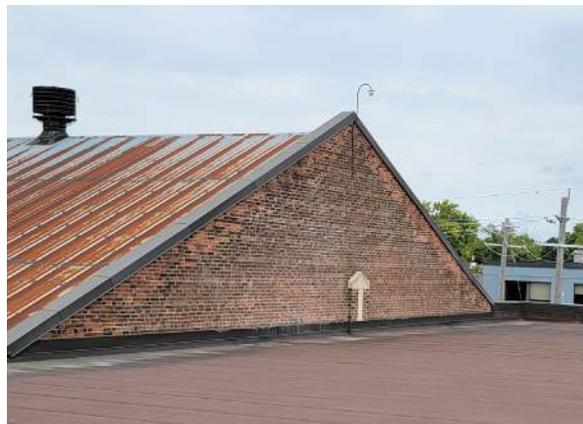
Figure 64. South gable partially exposed above the flat roof of a later extension south (ERA, 2022).

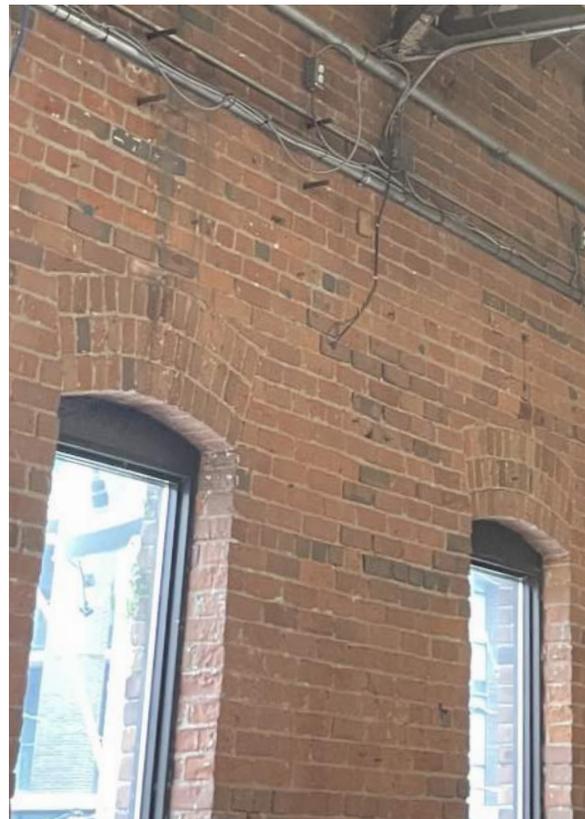
Figure 70. Window openings with segmental arch (ERA, 2022).

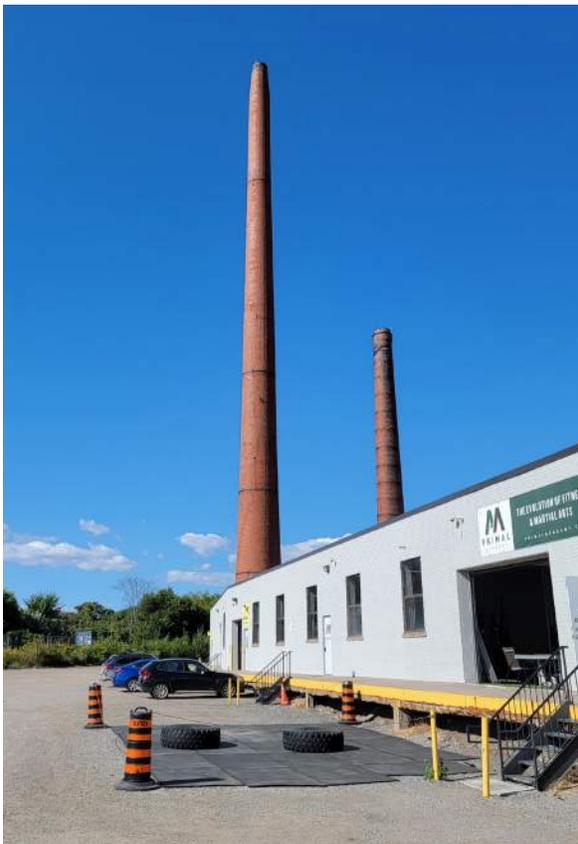
The 1939-1950 west addition has a painted brick exterior, aluminium windows, and loading docks that are in poor condition. The exterior of the brick wall has visible signs of spalling and mortar loss. The parapet coping includes clay tiles or painted metal flashing in good condition. The membrane roof is in poor condition with visible water pooling in sloped sections and noticeable surface wear. This portion of the building includes hallways, elevators, stairs and loading areas. Interiors include steel columns with supporting steel beams and wood planking.

Figure 71. West elevation loading dock at the rear of the building (ERA, 2022).

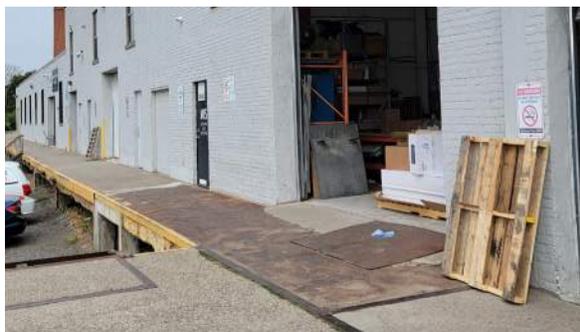
Figure 75. West elevation overhead door with corroded loading dock. Painted brick is deteriorated with extensive mortar loss on the upper portion of the wall (ERA, 2022).

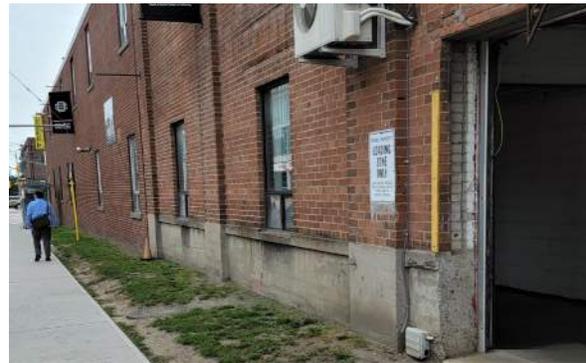
Figure 73. Brick piers separate each bay. Openings at grade have been modified for additional loading areas (ERA, 2022).

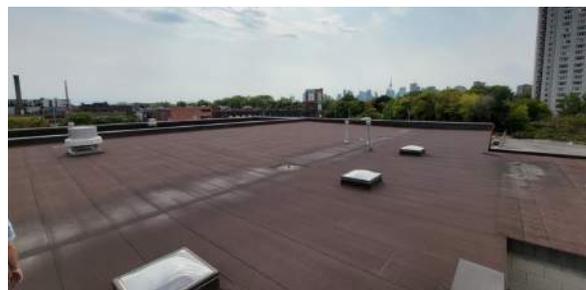
Figure 74. Roofing membrane with ponding and general deteriorated surface (ERA, 2022).

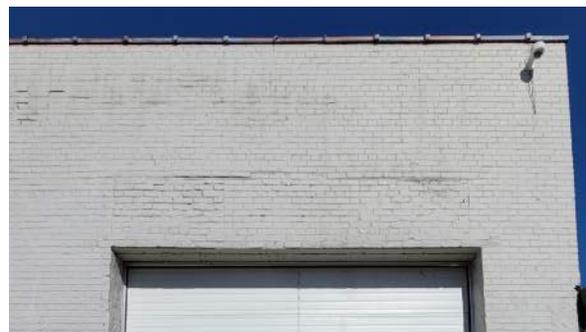
Figure 76. Brick spalling and mortar loss is evident under the painted surface (ERA, 2022).

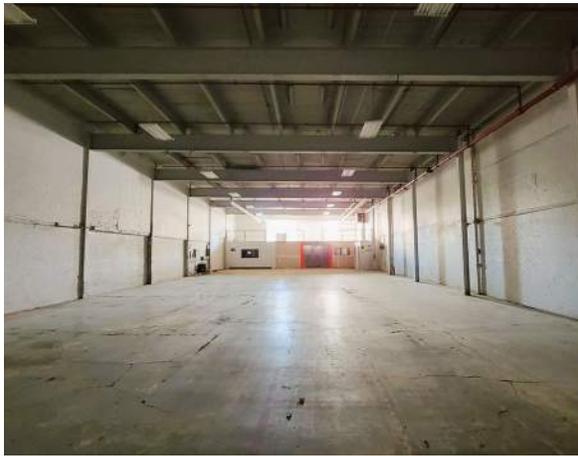
Figure 77. Looking west on second floor. This area has steel columns and painted brick (ERA, 2022).

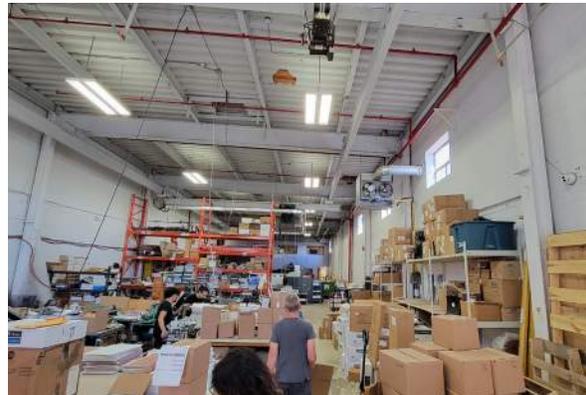
The interiors of the 1939-1950 south addition are varied in design with large open units. Exterior and demising walls are made of painted brick and concrete block which are in poor condition, with portions of the south wall in defective condition. Steel support columns are either embedded in the walls or along wall faces, providing clear span spaces. The steel system is in fair condition. The interior unit facing Carlaw Avenue is finished with wood floors and drywall and in good condition. A gantry crane midway through the space is no longer operational. The roof consists of steel purlins, rafters and a corrugated metal deck that are in fair condition.

Figure 80. Interior with painted masonry walls (ERA, 2022).

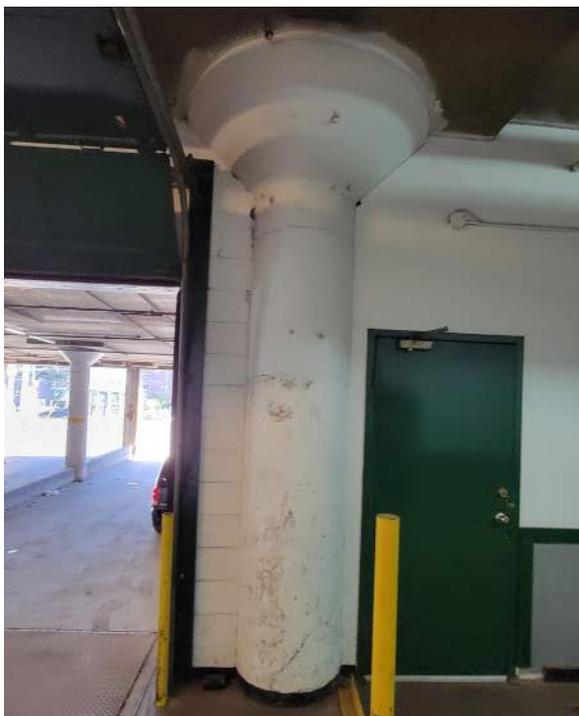
Figure 85. View of concrete column (ERA, 2022).

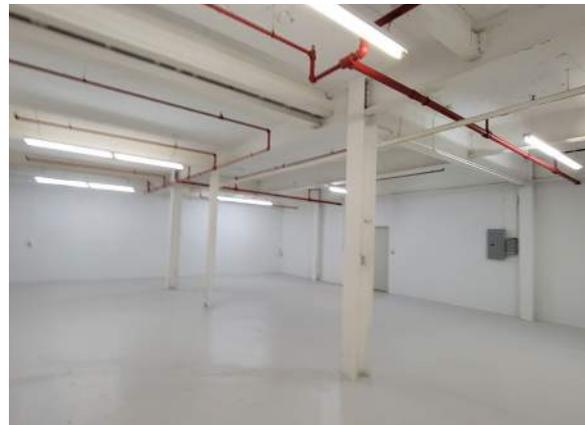
Figure 87. First floor unit with steel columns and concrete floor above (ERA, 2022).

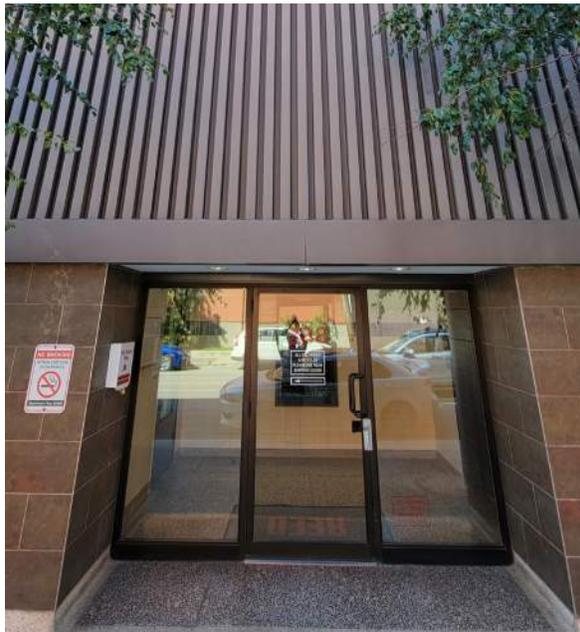
Figure 91. Main entrance with terrazzo floors and tile on exterior walls, and painted metal cladding above (ERA, 2022).

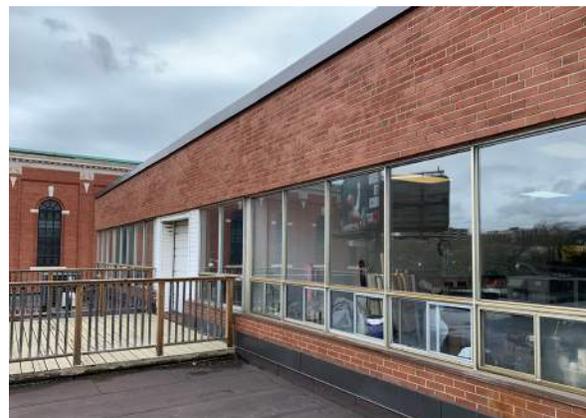
The 1939-1964 north addition was constructed in several phases, with a third floor added in 1960-1964. The main entrance to the north addition on the east elevation has been clad with painted corrugated metal in good condition, has tiled walls and multi-coloured terrazzo floors in fair condition. The entrance includes a typical commercial metal and glass door with two sidelights in fair condition. On the west elevation, openings have been modified and masonry is soiled. The condition of the west and north elevations of the building range from poor to fair. The roofing membrane is in poor condition.

Figure 92. View looking east on the roof of the north addition (ERA, 2022).

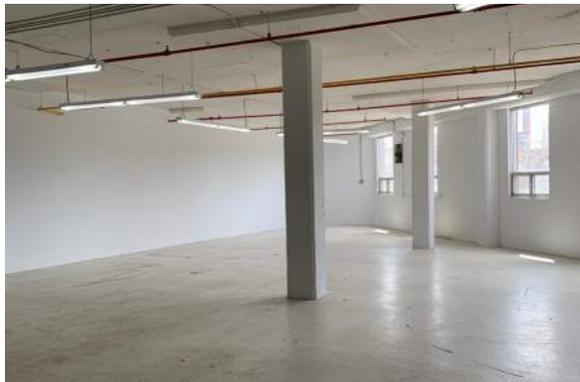
The interior of the north addition consist of concrete and steel structural members with concrete floors, brick and concrete block walls, and punched window openings. The masonry units are generally in good condition, with deterioration noted in loading areas and hallways in fair condition. The ground floor entrance on the east elevation includes tiled walls and a terrazzo floor in fair condition. The second floor includes concrete and steel columns and steel joists. The interiors appear to be in good condition. Aluminium windows are in poor condition with damaged frames, glazing and deteriorated sealants throughout.

Figure 94. Concrete columns, ceilings and walls (ERA, 2022).

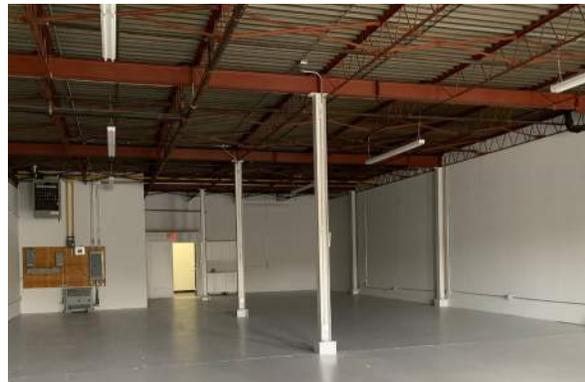
Figure 95. Steel columns connect to steel beams (ERA, 2022).

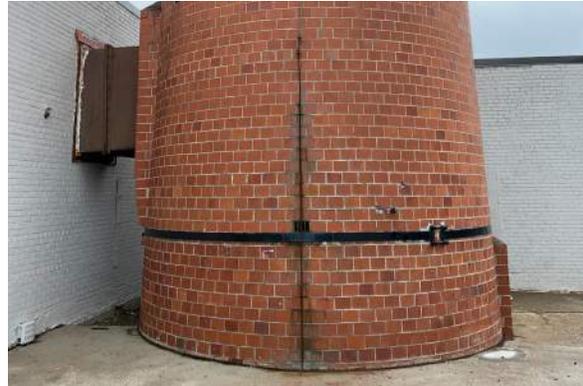
The west elevation of the north addition includes two chimney stacks that were observed from the roof and at grade. The taller c. 1969 west stack rests on an exterior concrete slab with a flue duct connecting it to the building and a cast steel ash door on the west side. The stack appears to have had previous repairs, with many bricks replaced. Some of the brick exhibits soiling and spalling. Vertical cracking was not visible. Tension bands and the grounding system are in fair condition, with some evidence of corroded steel. The west stack is generally in fair condition. The shorter c. 1940 east stack has numerous tension steel straps with surface corrosion, and overall appears to be in poor condition with masonry spalling, vertical cracking and soiling. The shorter east chimney emerges from a two storey area of the building with an octagonal base with venting, and copper flashing. The metal is in poor condition with open seams and visible corrosion.

Figure 98. Taller west chimney exhibiting soiling, spalling and rusted steel tension bands (ERA, 2022).

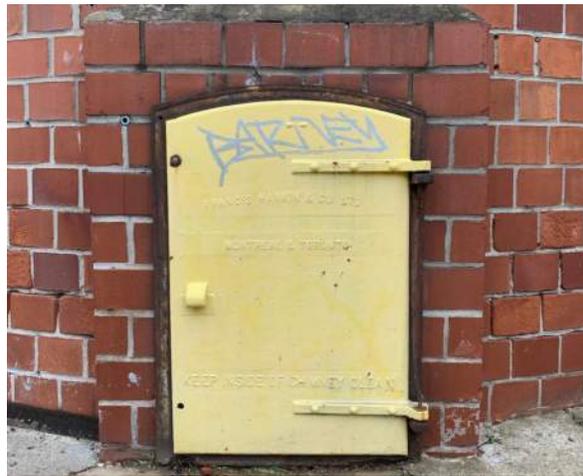
Figure 99. Ash door at the taller west chimney (ERA, 2022).

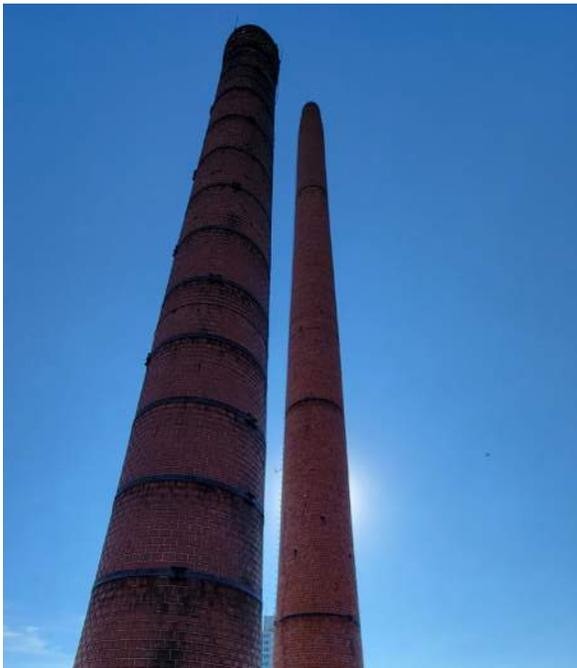
Figure 100. The shorter east chimney in the foreground with steel strapping, and taller west chimney beyond (ERA, 2022).

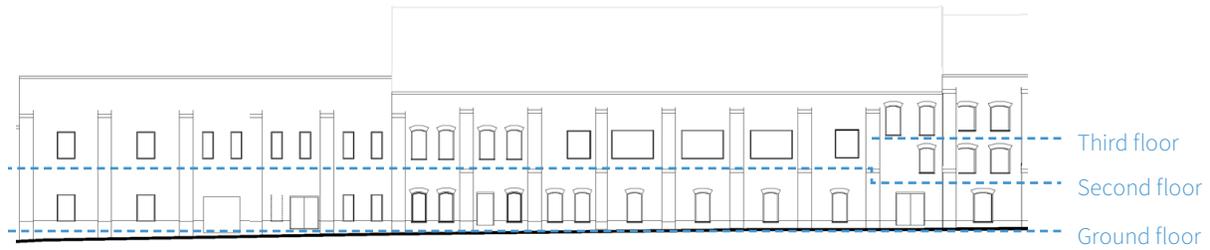
Impact: Removal of the existing windows on the retained east elevation.

Figure 118. Partial existing east elevation (SvN, 2022; annotated by ERA).

Rationale and Mitigation: The removal of windows is required to facilitate the in-situ retention of the east facade. The removal is mitigated by the provision of new, historically appropriate windows that will enhance the character and appearance of the heritage facade as seen from the street. The configuration and details of the new windows will be proportioned to the modified window openings.
